Comparison of Two Tiltrotor Crashes – Lessons and Guesses

Investigation documents of the 2022 eVTOL crash of Joby were published recently. The March 25, 2024 issue of the Vertical Magazine has the [details](#). Precision of data included in the report – not so frequently found in the similar press - deserves appreciation and respect. They allow e.g. to make some analyses of your own. In hope to find out even more I am sharing thoughts for discussion.

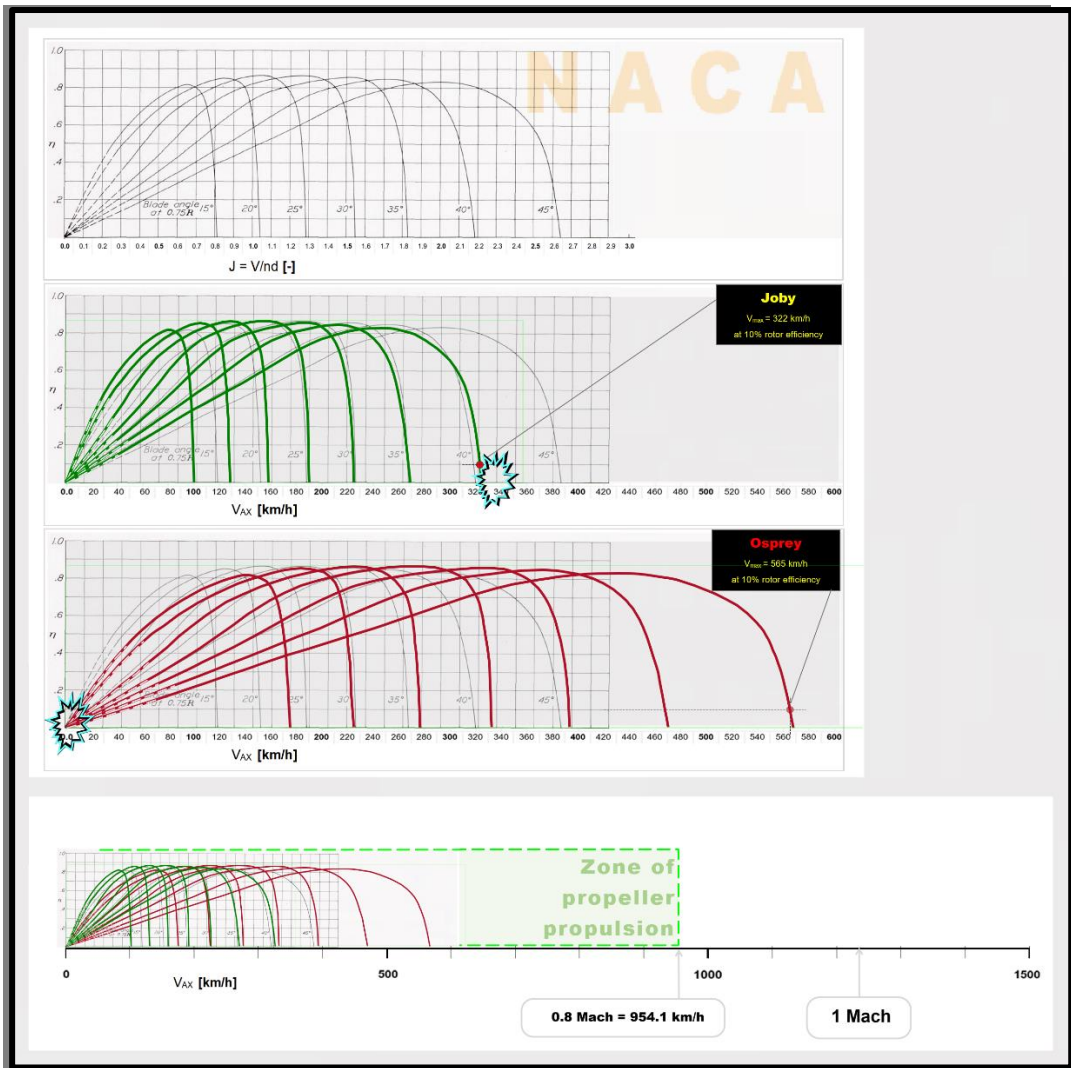
Finally, the selection was made. Actual test data of a 5868-9 (Clark Y section) type propeller, published in the 1939 NACA Report No 650, was used to prepare the below comparison chart.

To facilitate comparison the horizontal ADVANCE RATIO axis was converted to an AXIAL SPEED, V_{Ax} axis, and was calibrated in [km/h] units.

In terms of the axial speed, spots of the crashes were indicated on the charts – respectively one for the Osprey, and one for the Joby. To see more of the low speed status of the propulsion another figure called CORNERS have been prepared too, with zoomed-in fractions of the main charts.

This theory is supported by the shape of the green (Joby) curves in the comparison chart. Near the crash speed the **curves go steeply down**. Meaning that only a minimal increase of speed of flight in this zone can lead to a full loss of rotor thrust. And – as propeller torque still remains nonzero here – starting from this point on, all engine power is used to generate turbulence.

For Joby to remain safe it is enough to limit top speed. Is not too difficult a task to complete. Not very painful either - at least not at the first glance. (See more below!)

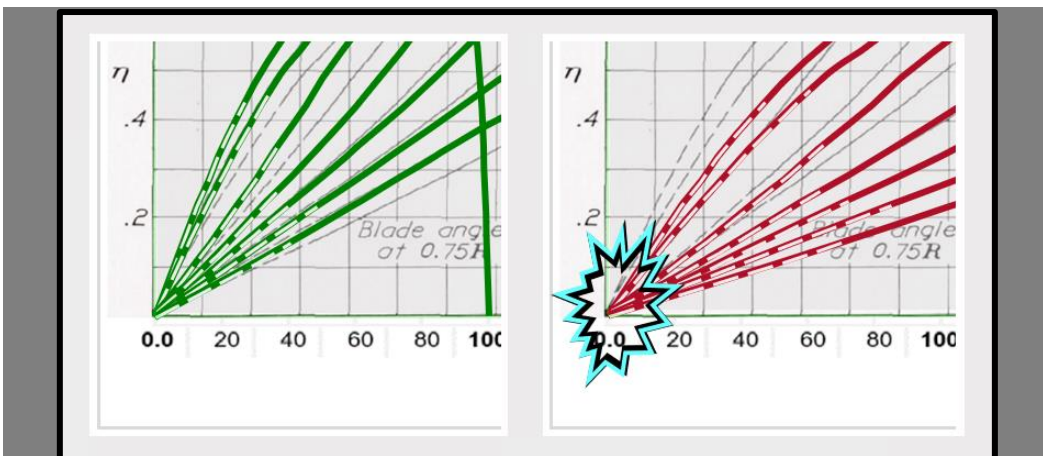
Joby propulsion, however, also has a strong point in the low speed zone, quite obvious from the charts too. The CORNERS image shows the green (Joby) curves of efficiency running much higher than the etalon NACA lines run. Beside good safety, this high rotor efficiency partly explains the silent operation of the S4 eVTOL during takeoff, hover and landing. (As the main reason of silence, of course, remains the electric propulsion of the S4.)

Red graphs of the V-22 in the CORNERS image span much lower than the etalon NACA lines do. And – hardly half as high as the Joby lines, at the same speed. It is of interest too that the zone of the dashed parts of the graphs covers about double (up to 90 km/h) of the speed range the same does for the S4 graphs. NACA reports comment they used dashed lines in such places where direct measurement was impossible. If we check the blade stall status in the above [chart](#), it can be understood why. A high bladetwist rotor (like that of the V-22) at zero, or near zero axial speed has all its blades partly stalled, and partly windmilling – at the same time. A very unstable status making aerodynamic testing difficult.

Unlike the Osprey. The only way to improve safety at low speeds is to **limit use** of almost **all VTOL capabilities**: no vertical takeoff and landing; no hover – especially not at low heights. Takeoff and landing shall be done in plane mode: by using runways always. Quite unhappy news.
